**PROPERTY CONDITION ASSESSMENT
OF
WORLD TRADE CENTER PORTFOLIO**

SUBGRADE

**Property #7
Merritt & Harris, Inc. Project Number 20-251E**

**Re: Due Diligence Physical Condition Survey
World Trade Center
New York, New York**

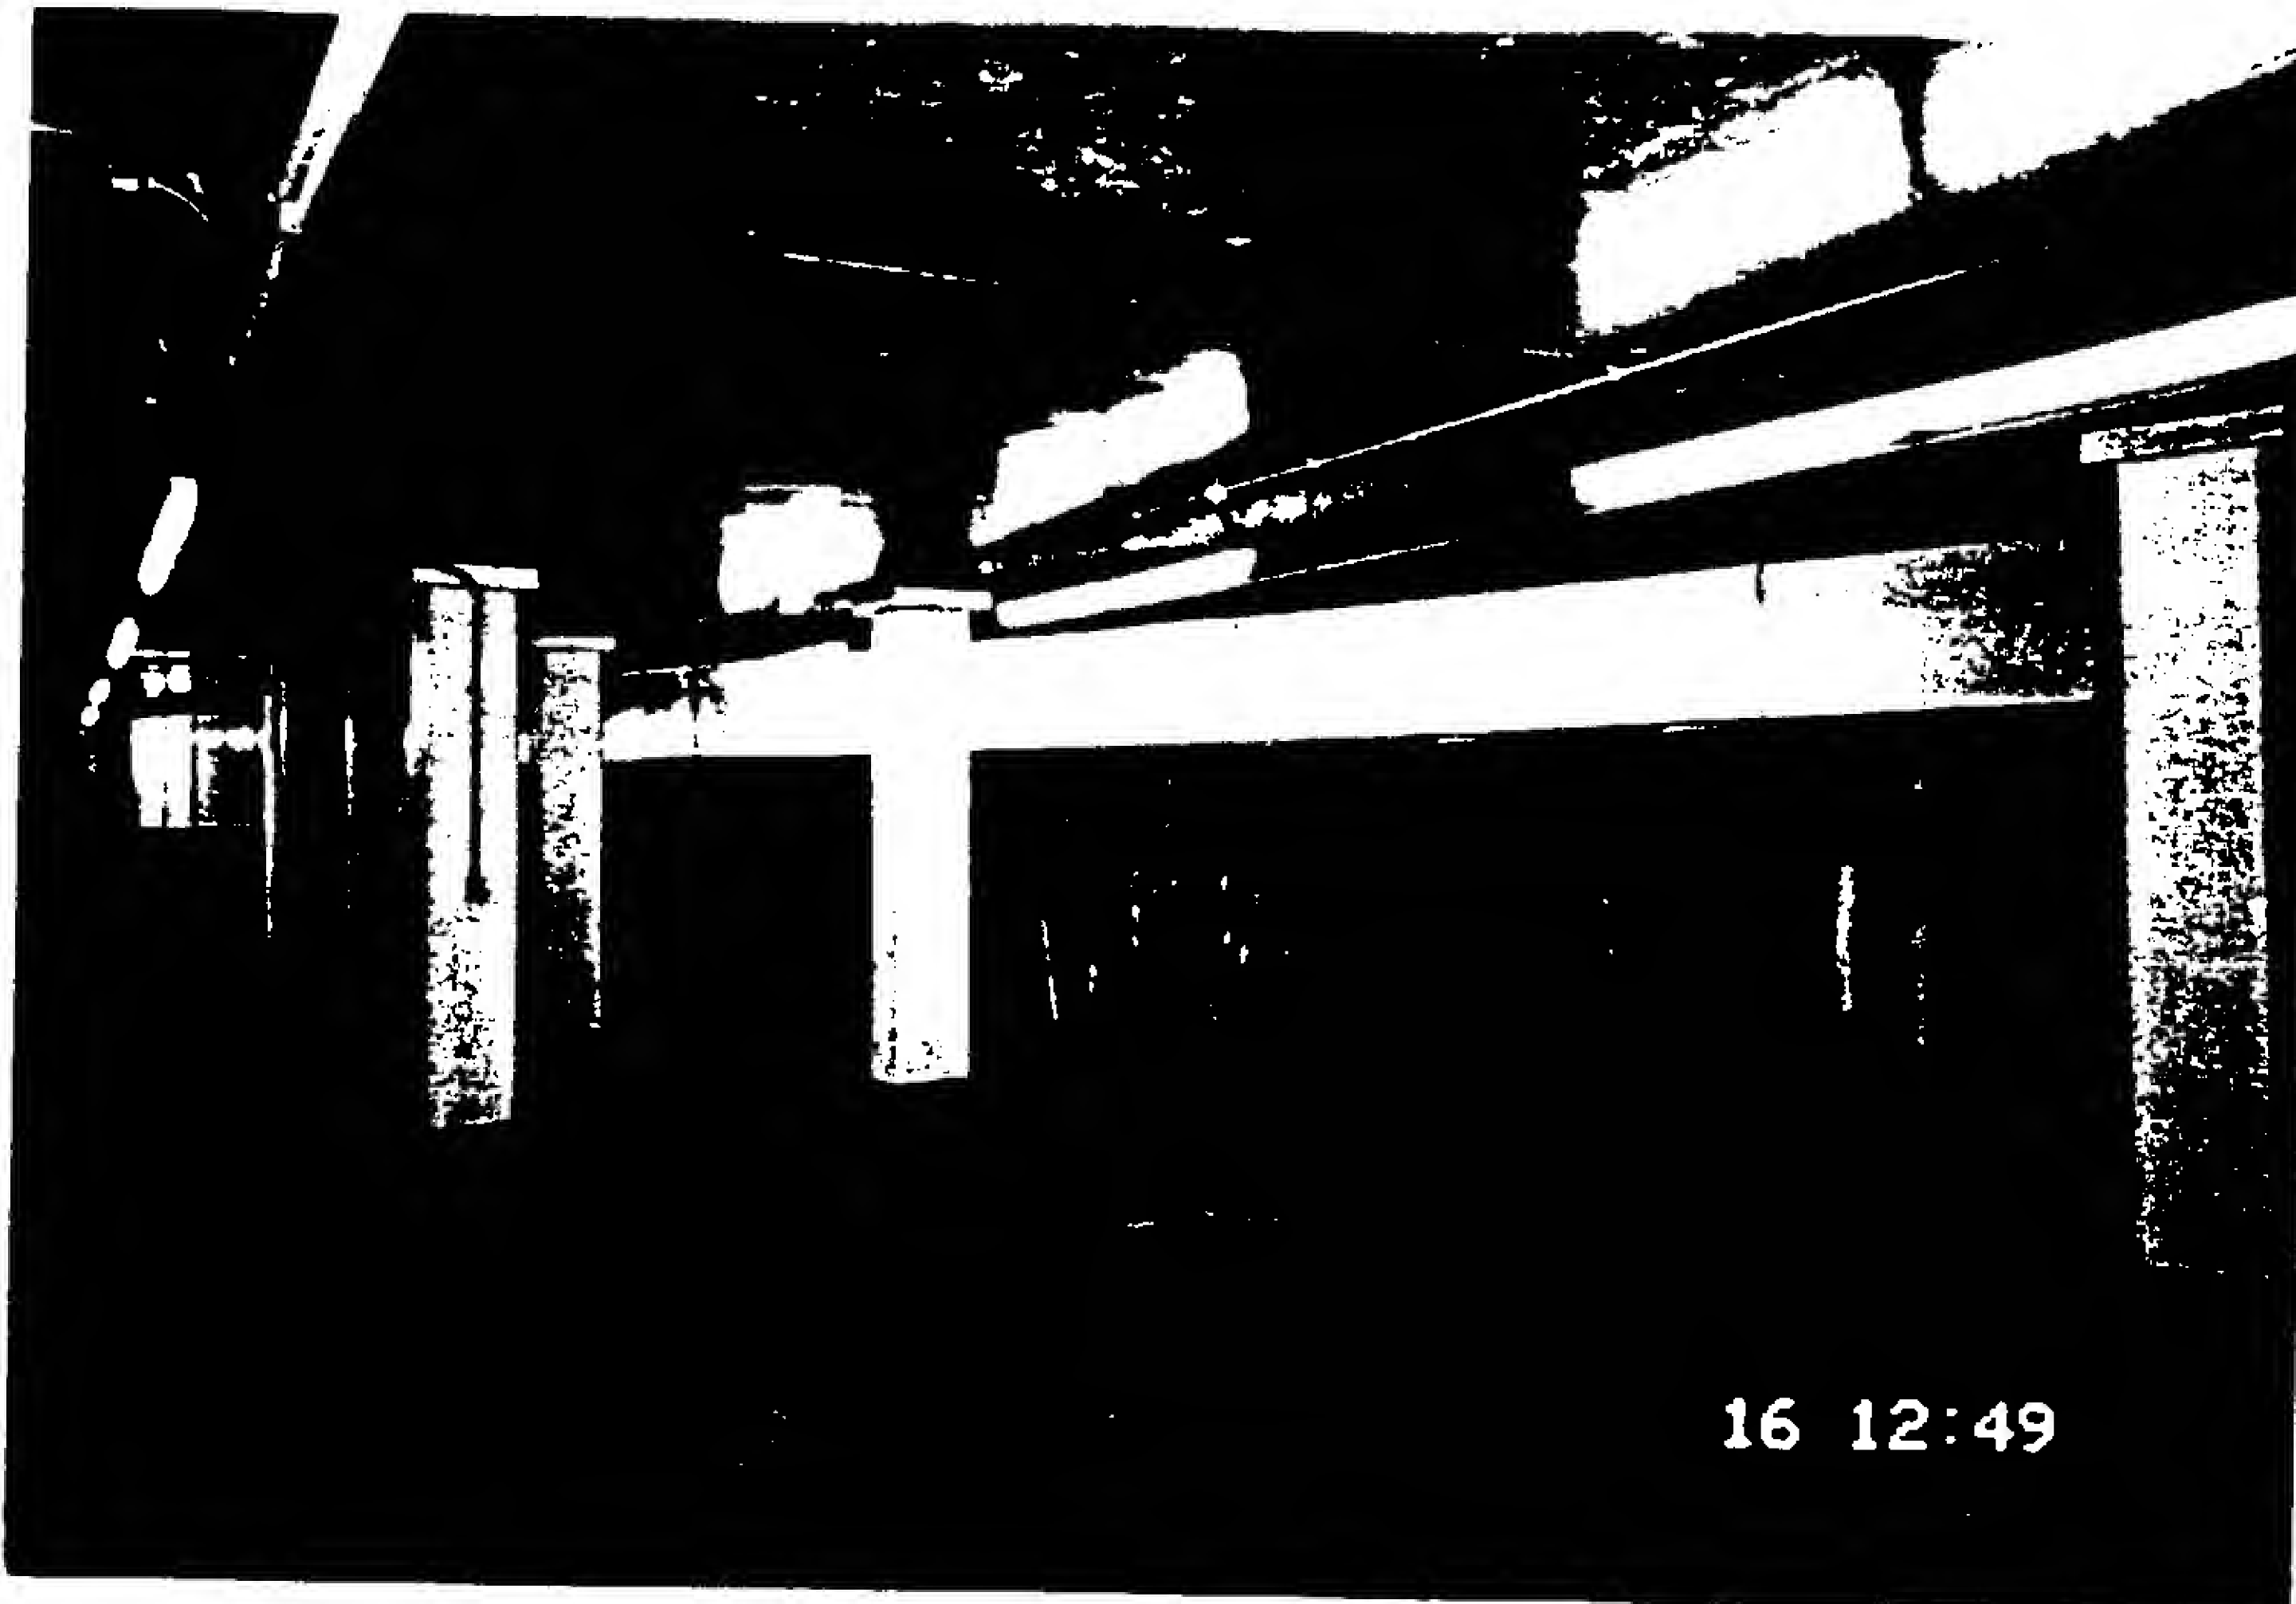
Photograph 1

Slurry wall exposed
in Level B5

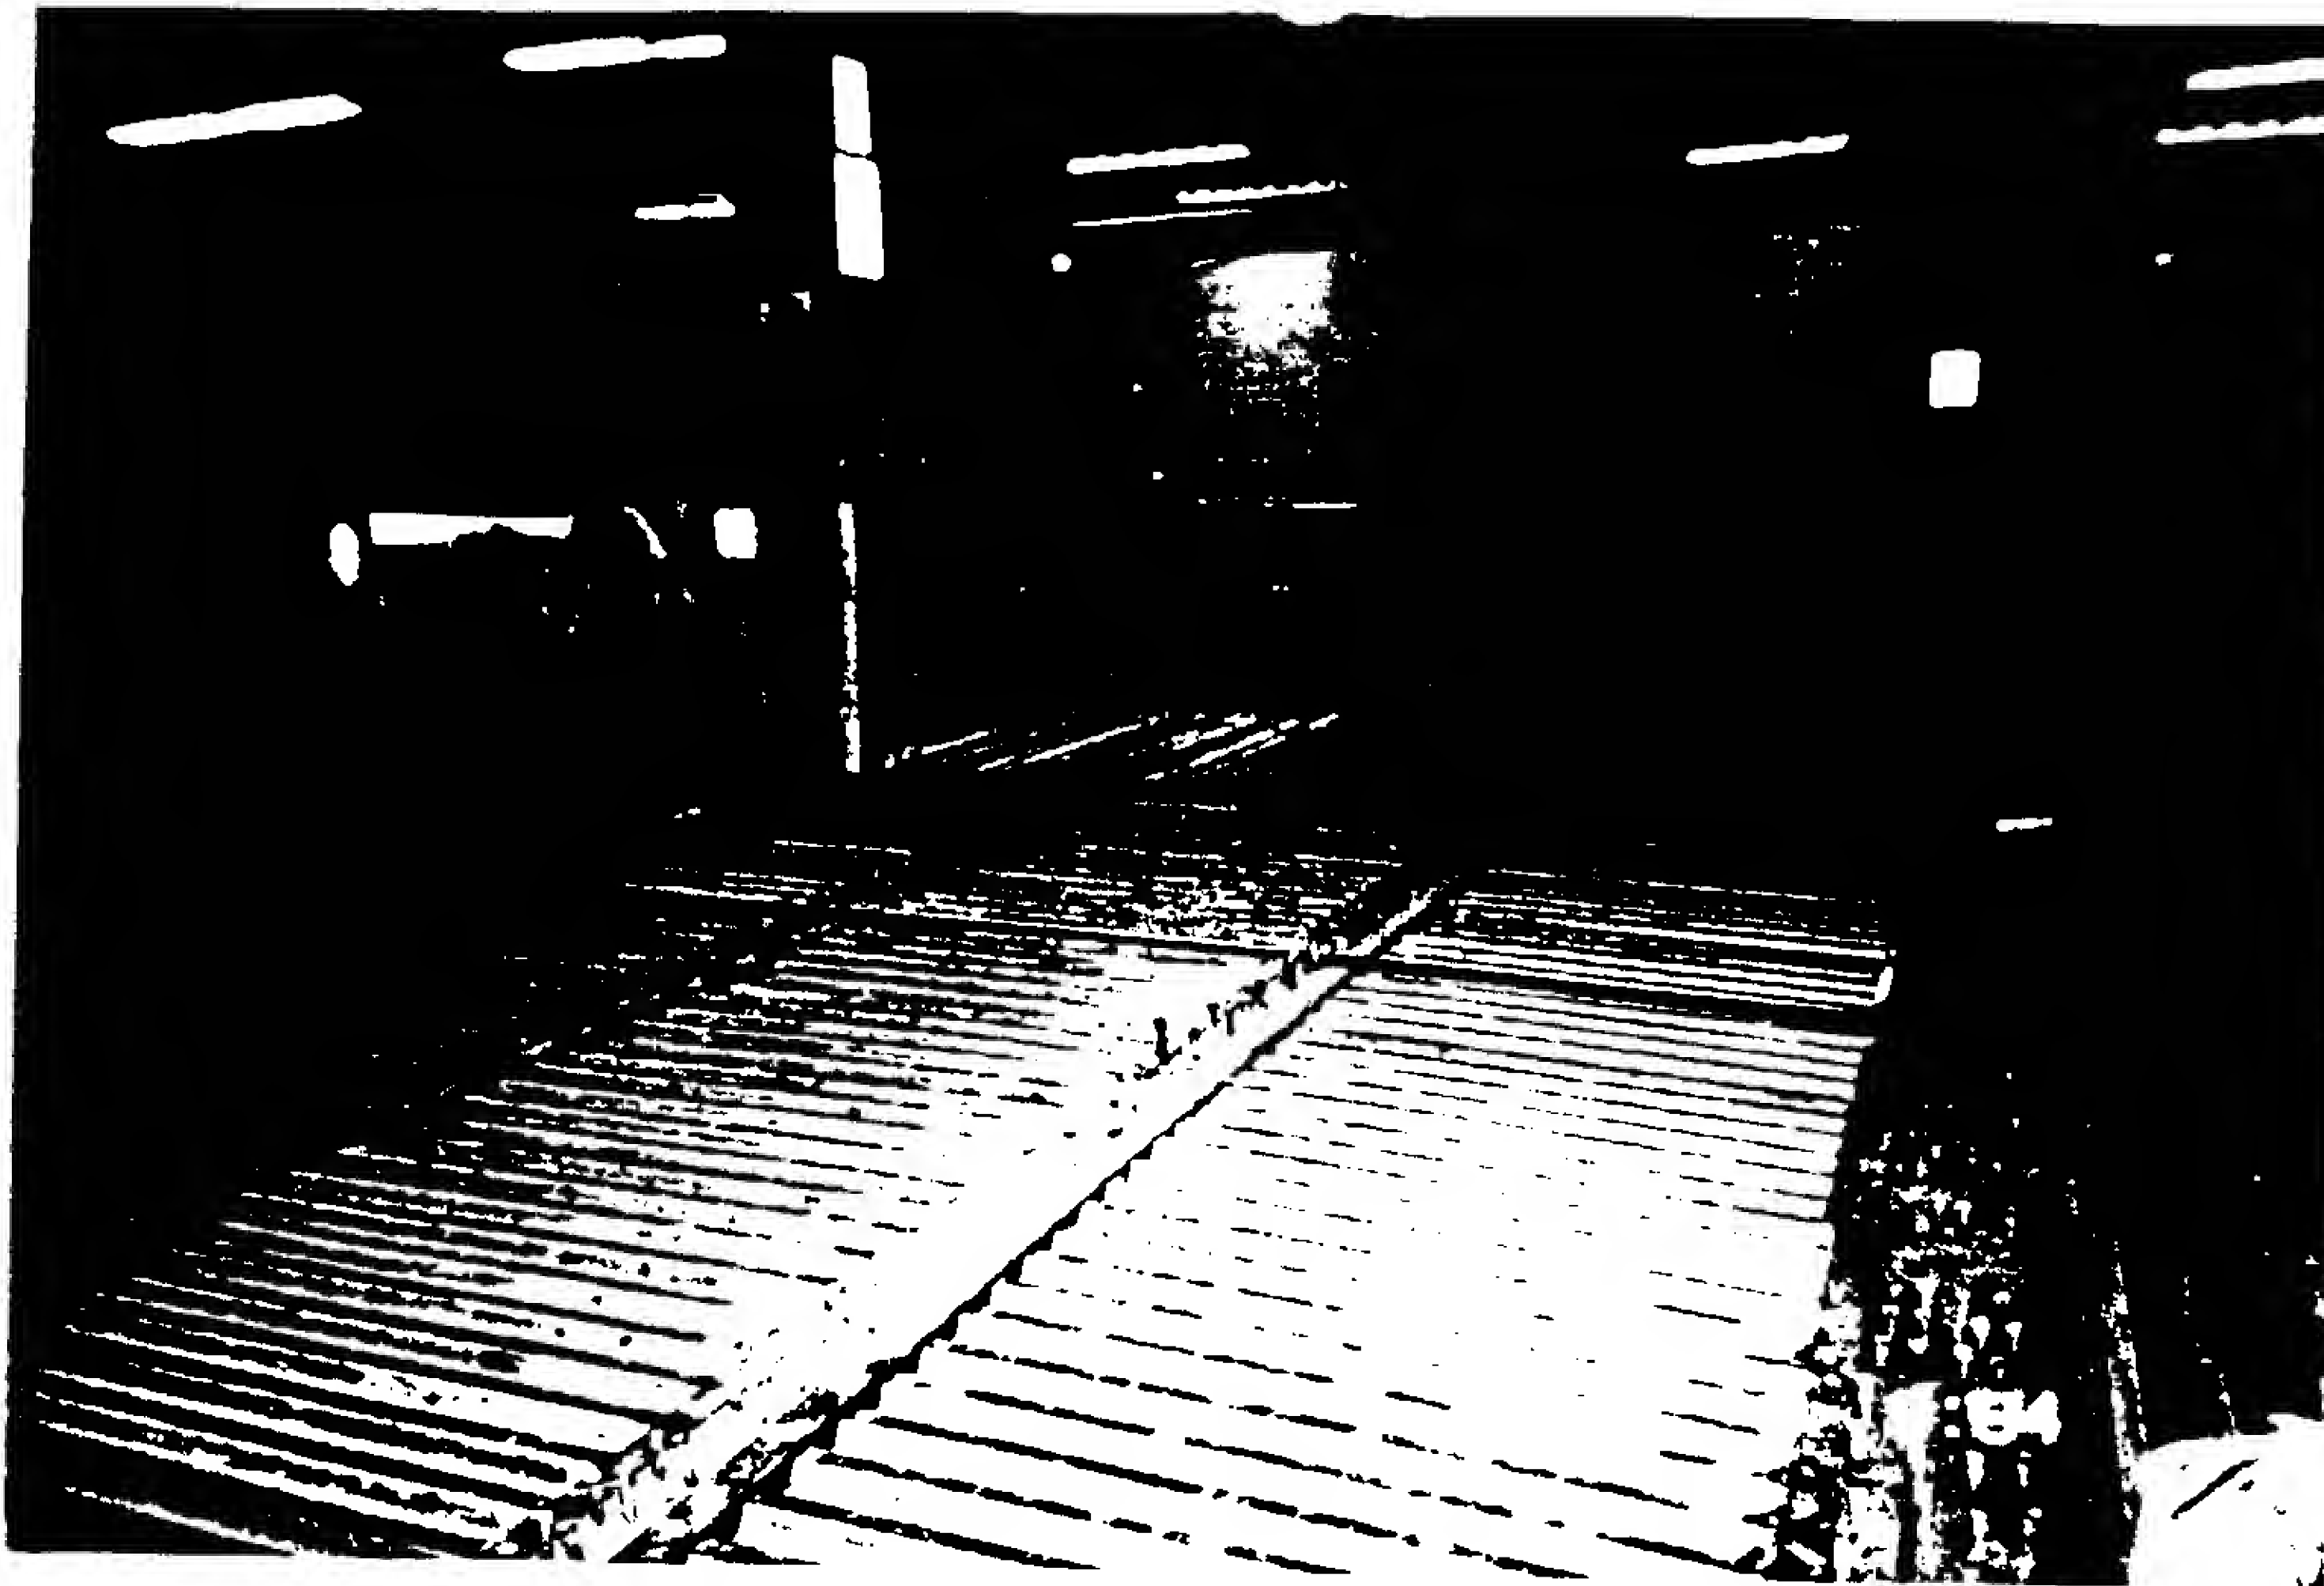
Photograph 9

New slab being
installed in loading
dock area - start of
multi-stage program
